Study of surface profile of rotary blades

RAVINDER KAUR AND AJAIB SINGH

■ **HOW TO CITE THIS PAPER** : Kaur, Ravinder and Singh, Ajaib (2013). Study of surface profile of rotary blades. *Internat. J. Agric. Engg.*, 6(2) : 415-419.

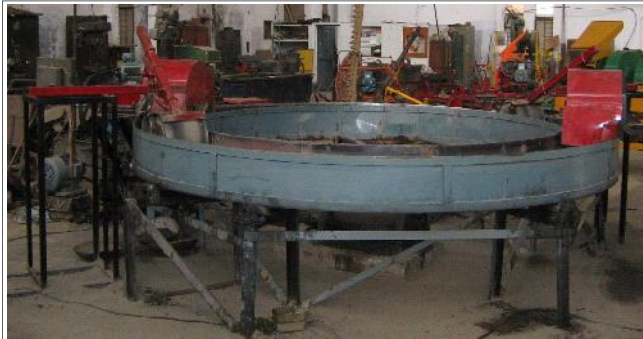
Fig. A: Rotary soil bin

For studying the wear characteristics of rotary blades, the study was conducted in rotary soil bin (Fig.A).
