Survey on structural details and evaluation of cattle sheds in coastal Odisha

ABSTRACT : A survey of the existing cattle sheds was taken up in three selected villages of Balasore, Khurda and Cuttack districts of coastal Odisha to collect the information on land holdings, structural details along with number and size of animals kept inside it. Considering different ideal characteristics, an evaluation score card for cattle sheds in tropics was developed. Based on the total score, the sheds were classified to four categories like very good (>25 points), good (21-25 points), satisfactory (15-20 points) and improper types (<15 points). It was observed that no particular specifications were followed by the farmers during construction of cattle / bullock sheds in any of the surveyed districts of Odisha. Bullocks were sheltered along with cows and calves in one shed. The size of the shed varied according to the number of animals kept inside. It was found that 85 – 90 per cent of the cattle sheds in coastal Odisha were in the category of improper type and only 10 – 17 per cent were under satisfactory category while no shed came under the category of good or very good type.

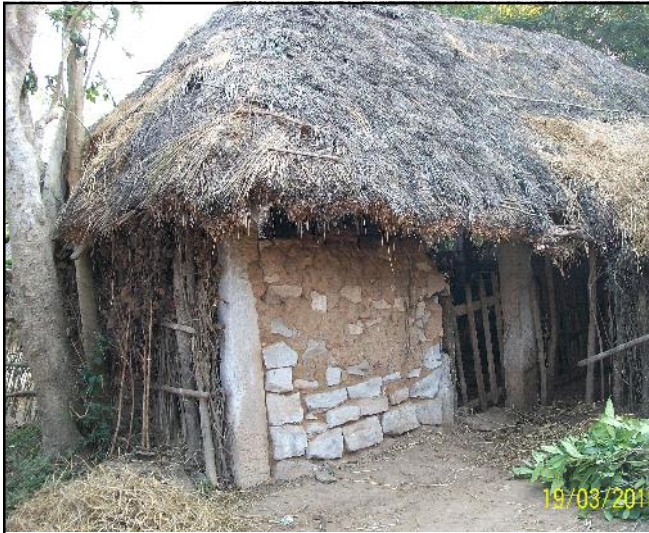
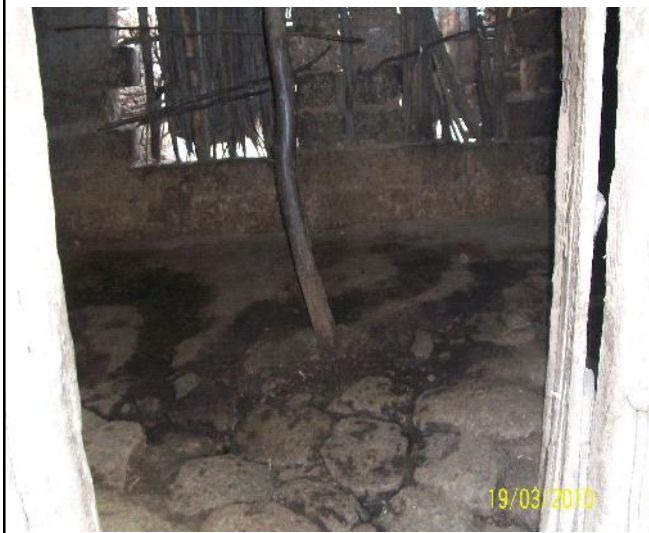
Fig. 1 : Outside and inside view of the common cattle sheds of coastal Odisha

While constructing the shed, no particular direction was preferred. It was built as per availability of the space and site near by the house of the farmer. In most of the cases, the roof was thatched one and in few cases it was of GI sheet or tile.

The roof height at centre of the shed also varied widely and in most cases due to low height roofs the air space per animal was less than 400 cubic ft. The wall in many cases was wooden stump fencing and in some cases was made of mud plus stone/brick. Hardly there was concrete walling. Ventilation was observed to be inadequate to average. In most of the cases floor was undulating one without proper gradient (Fig.1). In some cases stone plates, bricks and stones were set on the floor but not properly. The floor space per animal varied from 25 to 36 sq. ft. Concrete flooring was rarely found. In many cases there were earthen/stone or brick urine channels without proper gradient resulting in improper drainage. In very few cases, concrete urine channels were observed.

Most of the farmers of coastal Odisha did not follow the ideal specifications while constructing the cattle shed due to lack of concern, ignorance and cost involvement. It was found that 85 – 90 per cent of the cattle sheds in coastal Odisha were in the category of improper type and only 10 – 17 per cent were under satisfactory category while no shed came under the category of good or very good type. The floor and wall of many sheds could be improved to come under good and satisfactory category.
